**DRAFT FINAL
Environmental
Baseline
Survey Report**

**St. Louis
Army Ammunition Plant
St. Louis, Missouri**

Date Prepared	:	March 17, 2000
Tetra Tech Project No.	:	G0011-0054KRP02
Prepared by	:	Tetra Tech EM Inc.
Tetra Tech Project Manager	:	Michael Barlage
Telephone No.	:	(312) 856-8700
U.S. Army Aviation and Missile Command Project Manager	:	Valerie Shippers
Telephone No.	:	(256) 876-0211

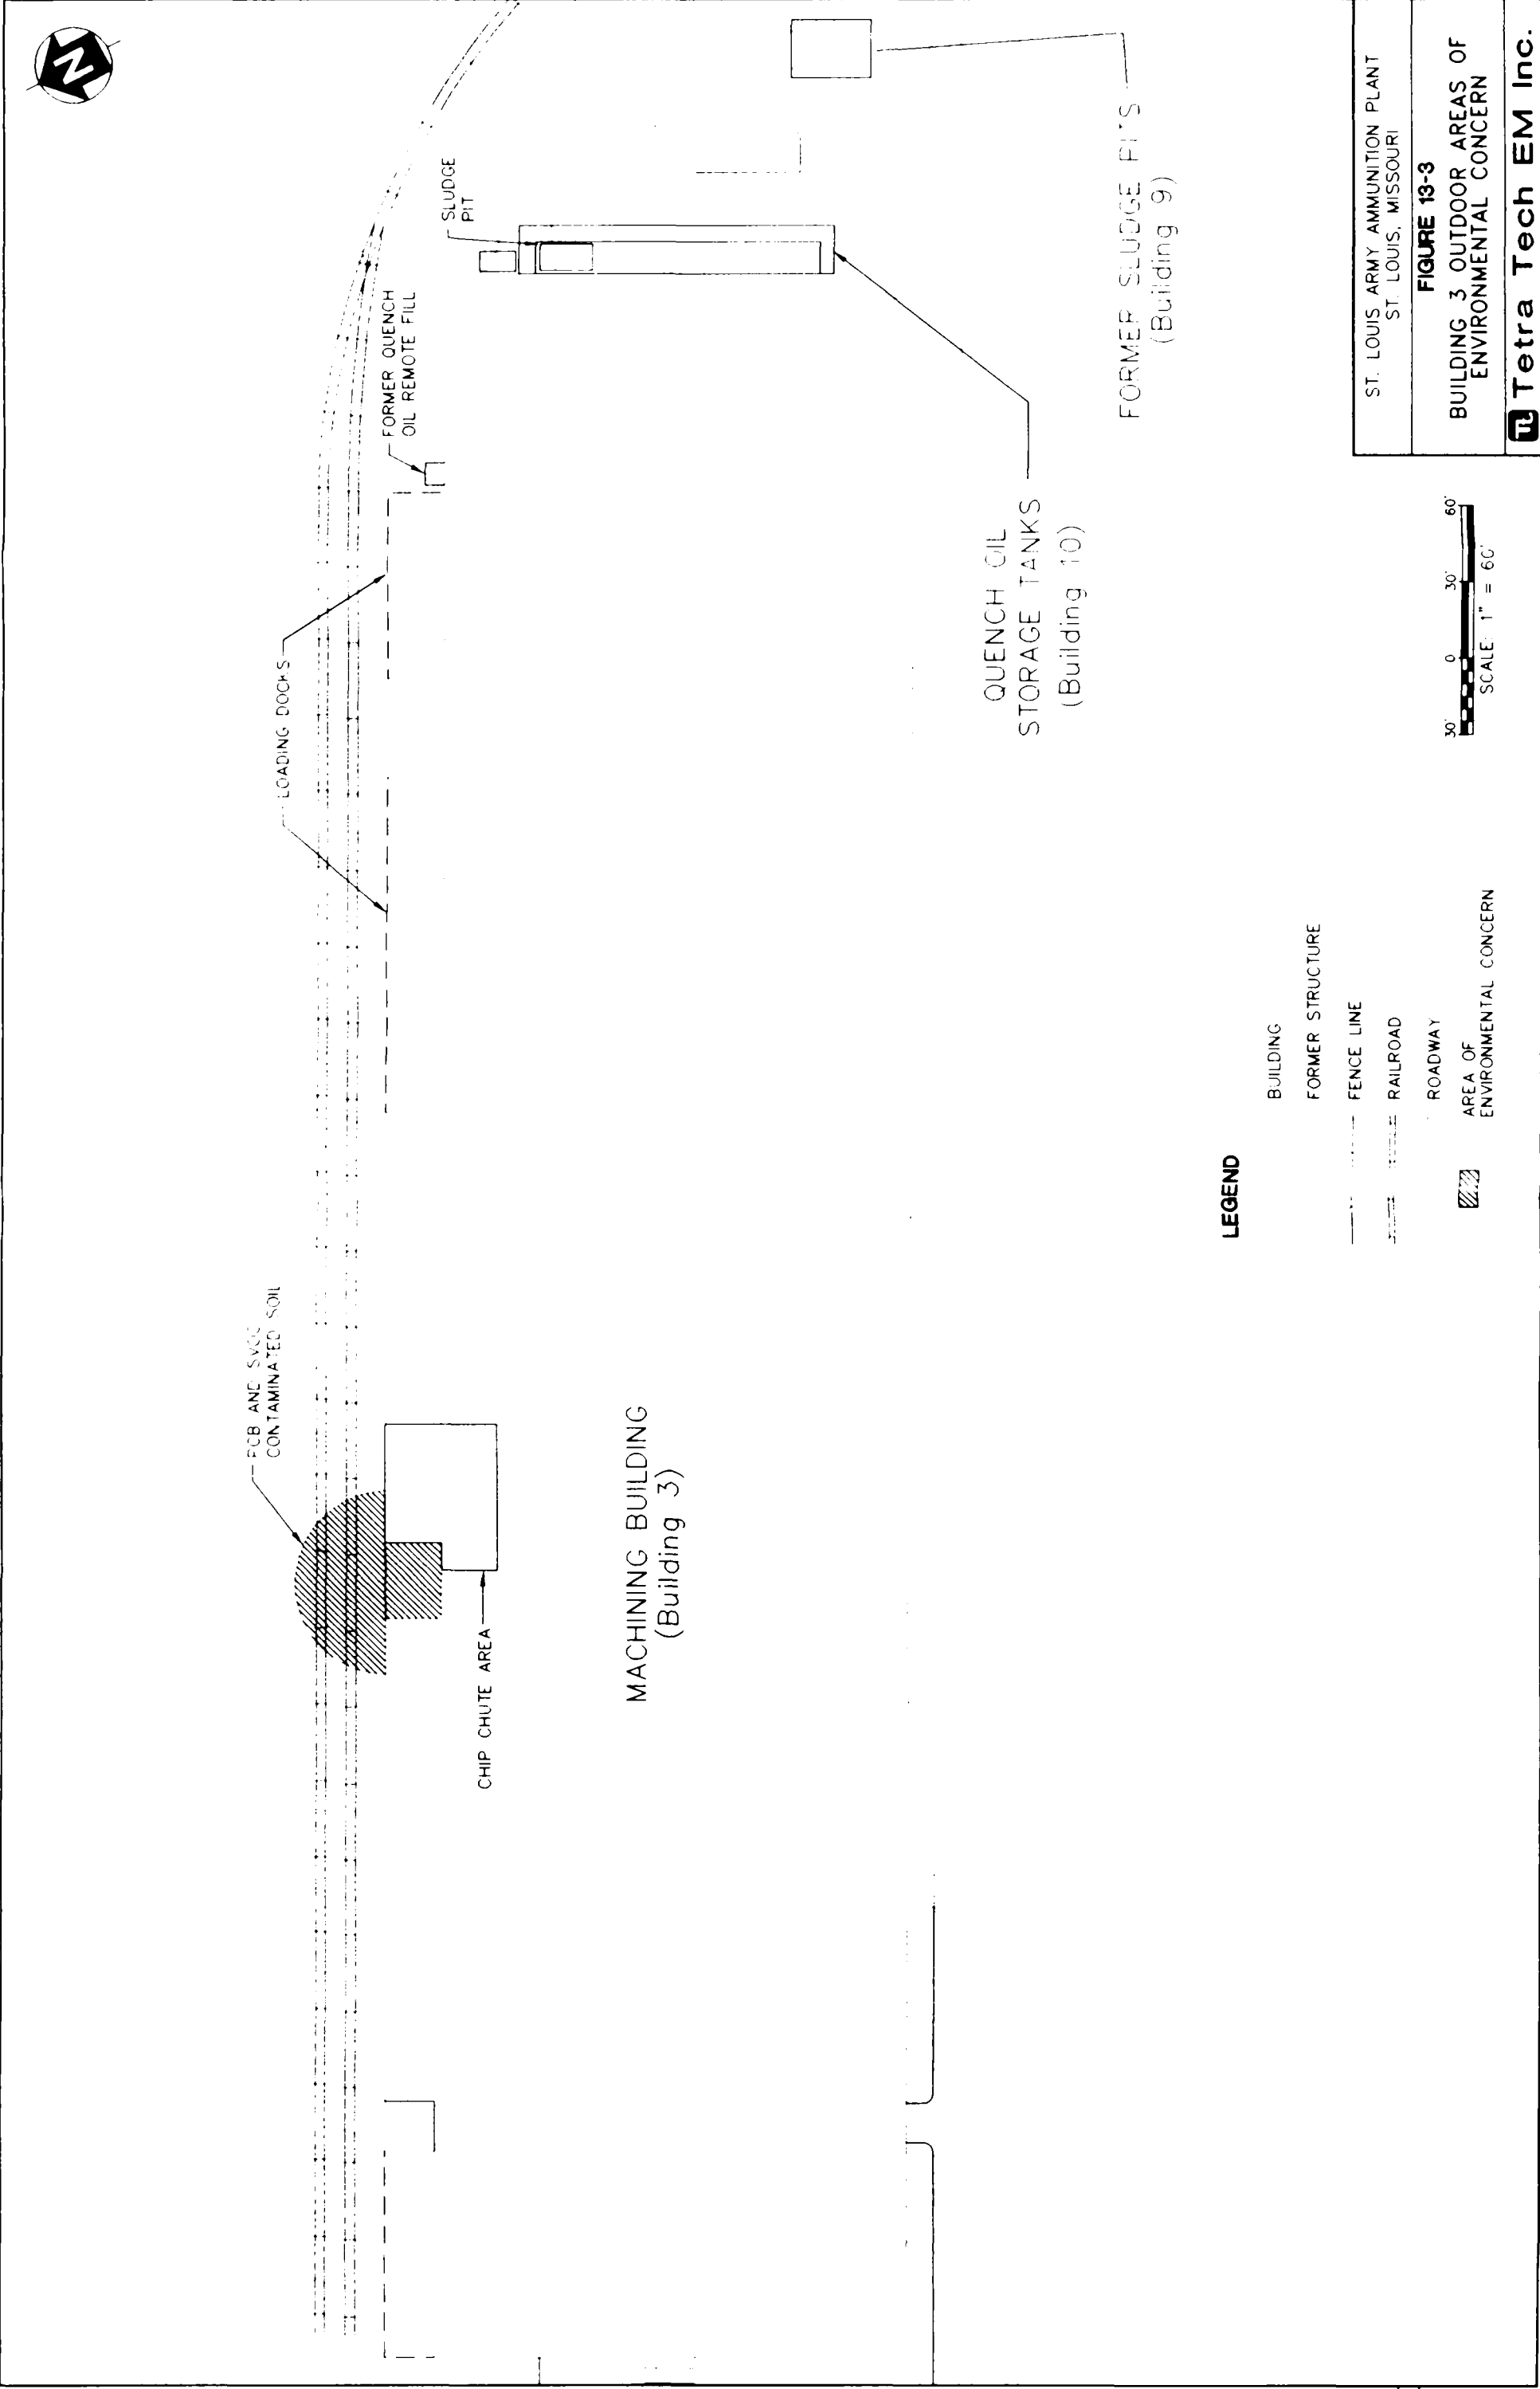
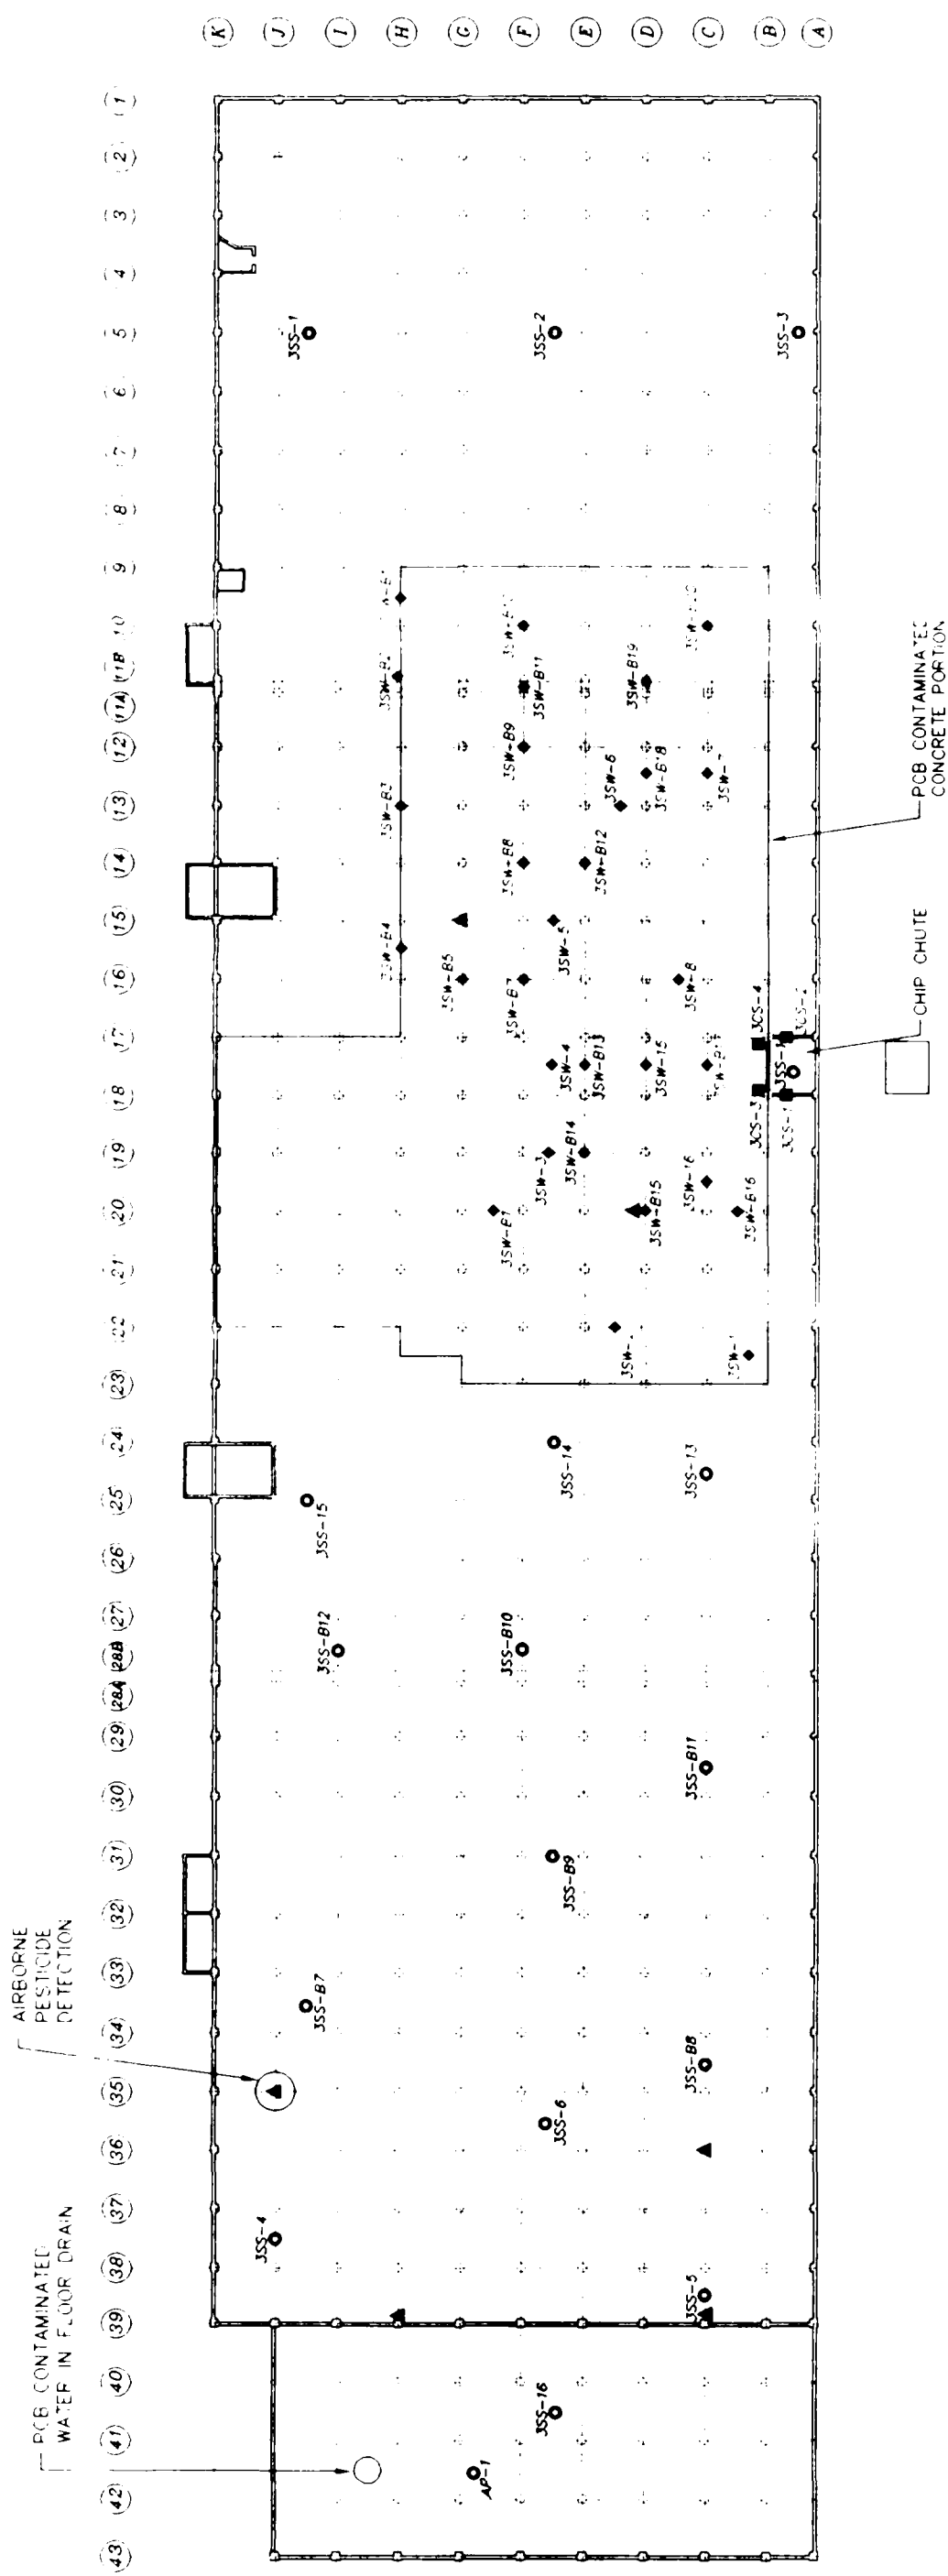
EBS investigation activities completed at Building 3 included completion and sampling of four soil borings and collection of 17 concrete core samples, 44 wipe samples, 23 surface soil samples, and 6 air samples. The soil sample collected from soil boring 3SB-3 contained concentrations of PCBs and SVOCs that exceed CALM criteria. Therefore, the vicinity of 3SB-3 is an area of environmental concern (see Figure 13-3). The soil boring was completed in the vicinity of the conveyor that transported metal chips from the chip chute to railroad cars. Therefore, it appears that the source of the contamination was spillage in the chip chute area. The concrete core samples collected from the basement and first-floor chip chute walls contained PCB concentrations that exceed CALM criteria; therefore, these areas pose an environmental concern. The core samples collected from the second floor and from concrete foundation members throughout the basement did not contain PCB concentrations that exceed CALM criteria. Wipe samples collected from the concrete portion of the basement indicate that surficial PCB contamination is present throughout the concrete portion (see Figure 13-4). Wipe samples collected from visibly stained areas of the concrete structures had PCB concentrations exceeding CALM criteria. The PCB contamination source was leakage from soluble oil piping and from holes in the ceiling of the basement. Except for one surface soil sample collected from the basement, the surface soil samples collected at Building 3 contained PCB concentrations below CALM criteria. Also, soil samples collected from the basement contained concentrations of metals and pesticides that did not exceed CALM criteria. The surface soil samples collected from the quench oil-stained portion of the basement did not contain PCBs and does not appear pose an environmental concern. The air samples collected in the east portion of the building contained pesticide concentrations that exceed U.S. EPA Region 9 PRGs for unrestricted use.

Recommendations for areas of environmental concern in Building 3 are listed below.

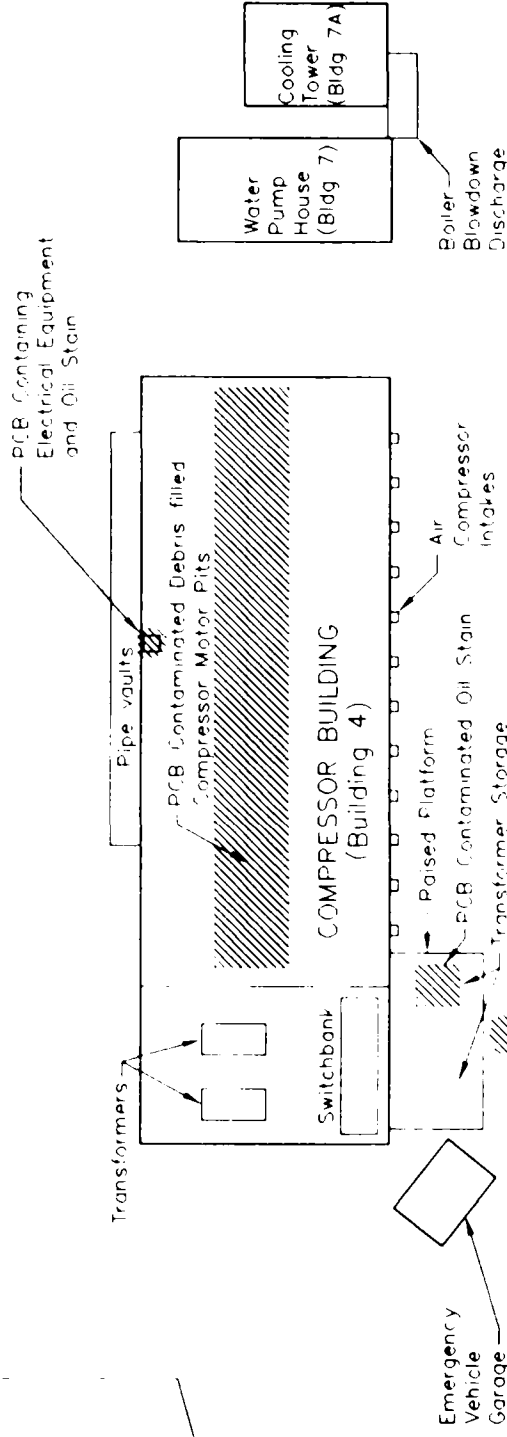
13.2.4 Building 4 Conclusions and Recommendations

At Building 4, the wipe samples collected from the oil stain below the electrical equipment and from the oil stain in the east transformer storage area contained PCB concentration exceeding CALM criteria. Therefore these areas pose an environmental concern (see Figure 13-5). The electrical equipment is to be removed. The stained areas below the electrical equipment and on the east transformer pad should be decontaminated to remove PCBs. Soil samples collected from the soil boring completed near the transformer pad did not contain PCB concentrations exceeding CALM criteria. Therefore, PCB contamination from transformers stored in this area does not pose an environmental concern. However, a soil sample collected from the soil boring did contain a concentration of benzo(a)pyrene that exceeds a CALM criterion by 0.01 mg/kg. Therefore, the soil in this area appears to pose an environmental concern. The only source of benzo(a)pyrene at SLAAP would be fuel oil or quench oil. Building 4 did not contain any process that used fuel oil or quench oil, and no staining, petroleum odors, or elevated headspace readings were identified during boring operations. Therefore, it seems unlikely that petroleum contamination was the source of the benzo(a)pyrene detected. Because the benzo(a)pyrene was detected on the surface of a grassy area located in a heavily industrialized area, the most likely source of the benzo(a)pyrene is an industrial process generating air emissions. The surface soil samples collected from the concrete-lined compressor pit contained concentrations of PCBs that exceed CALM criteria.
